CONDITION SURVEY OF
DEPERE LOCK AND DAM
LOWER FOX RIVER, WISCONSIN

Richard L. Stowe, Joyce C. Ahlvin

June 1982

CONDITION SURVEY OF DEPERE LOCK AND DAM
LOWER FOX RIVER, WISCONSIN

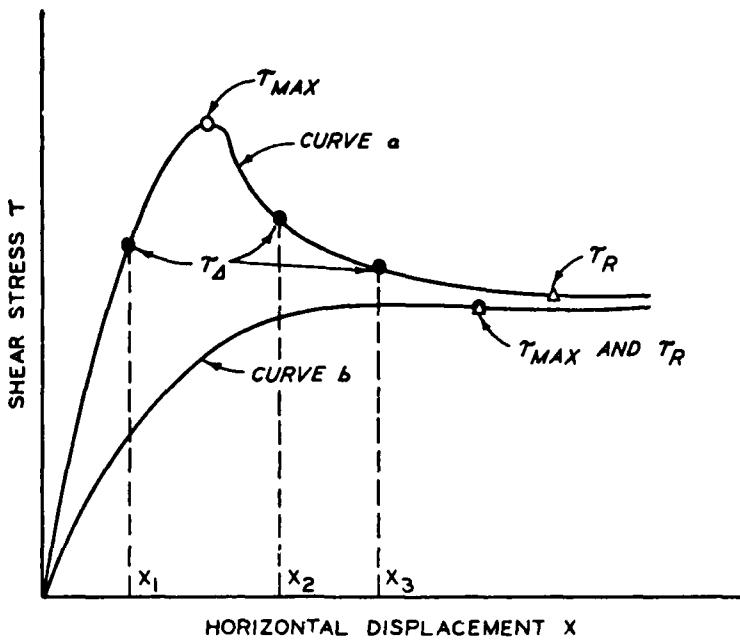
64. Designers are commonly interested in the maximum available shear strength. The maximum shear stress points are identified as τ_{\max} in Figure 1. The maximum shear stress usually corresponds to the peak of the shear stress versus displacement plot (curve a of Figure 1); however, some confusion may arise where strain-hardening is encountered. When strain-hardening occurs, an initial peak usually occurs at a relatively small displacement, followed by an increase in shear stress to a value greater than the initial peak. When this happens, the first peak is termed the maximum shear stress corresponding to initial failure and the latter is the ultimate shear stress.

65. If the residual shear strength is to be determined from the intact specimens, then displacement is continued until the shear stress approaches the horizontal asymptotic value of residual shear stress τ_R (curve a of Figure 1). When the zone tested exhibits only a residual shear strength, curve b of Figure 1 may be obtained. In such cases, the maximum shear stress attained is the residual shear strength; precut specimens exhibit this type of curve. The shear strength obtained from precut specimens approaches the residual shear strength.

Figure 1. Maximum and residual shear stress and displacement failure criteria, after Zeiglar.⁶

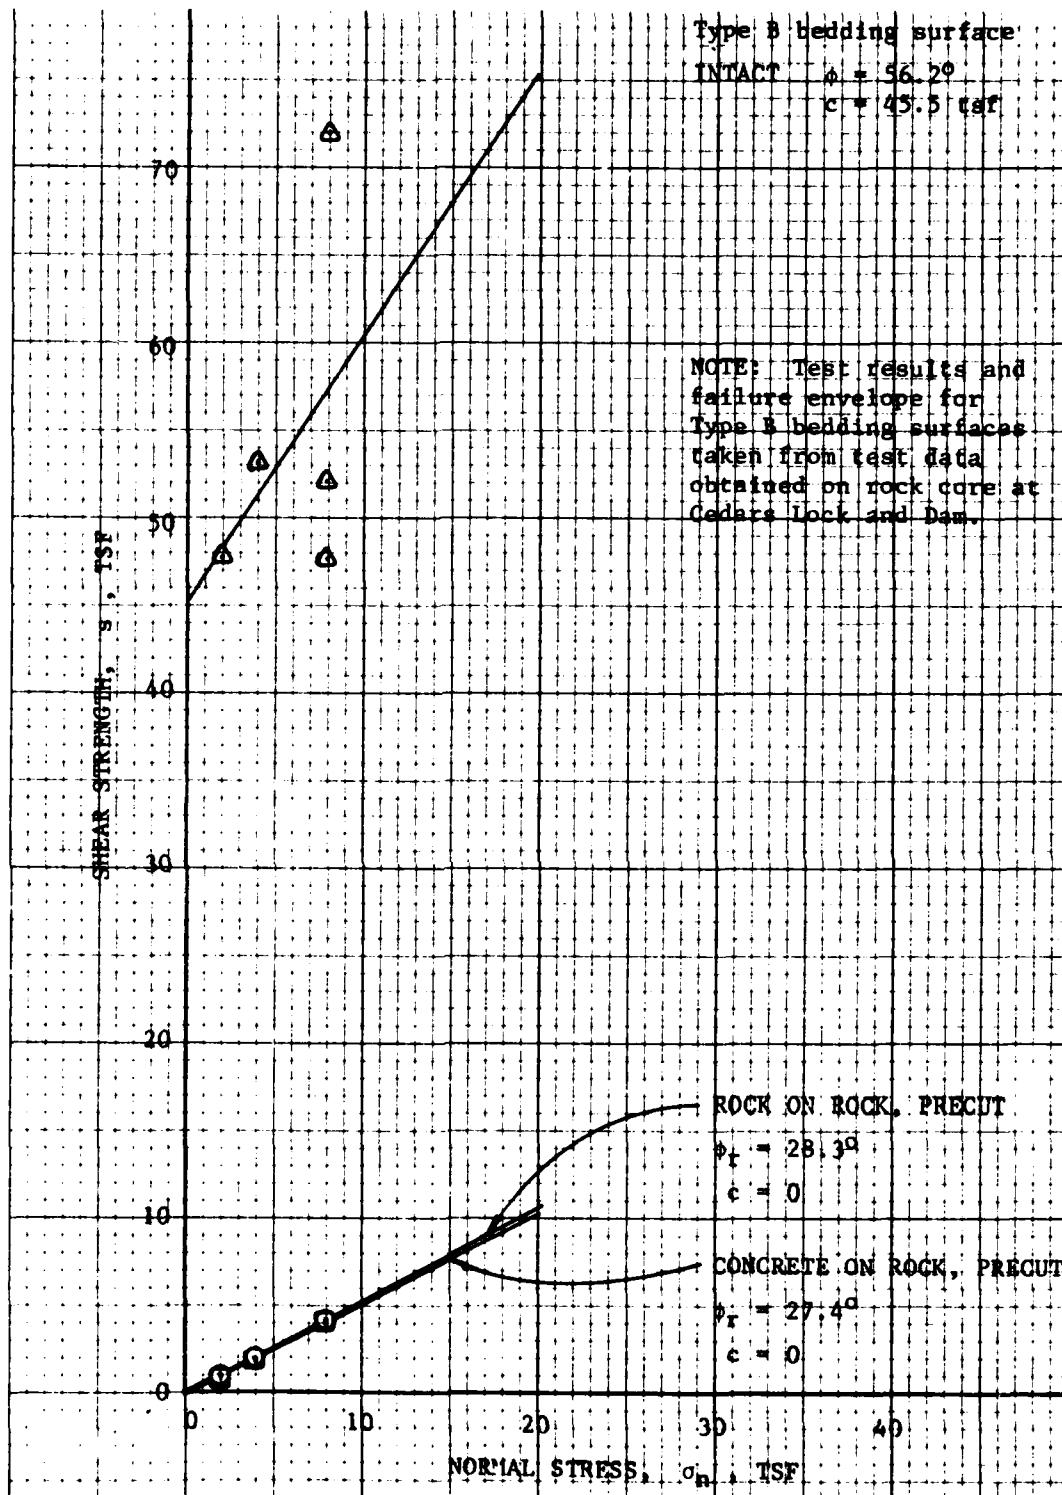
rock and rock on rock. The direct shear test results of intact specimens are presented in Plates 22 and 23; shear stress values, load-deformation curves, and typical normal versus shear deformation curves are presented. The direct shear test results from the discontinuous specimens tested as precut specimens are presented in Plates 24 and 25. Maximum and residual strength failure envelopes for the intact and discontinuous specimens are presented in Figure 2.

Figure 2. Direct shear test results, maximum and residual shear strength failure envelopes.

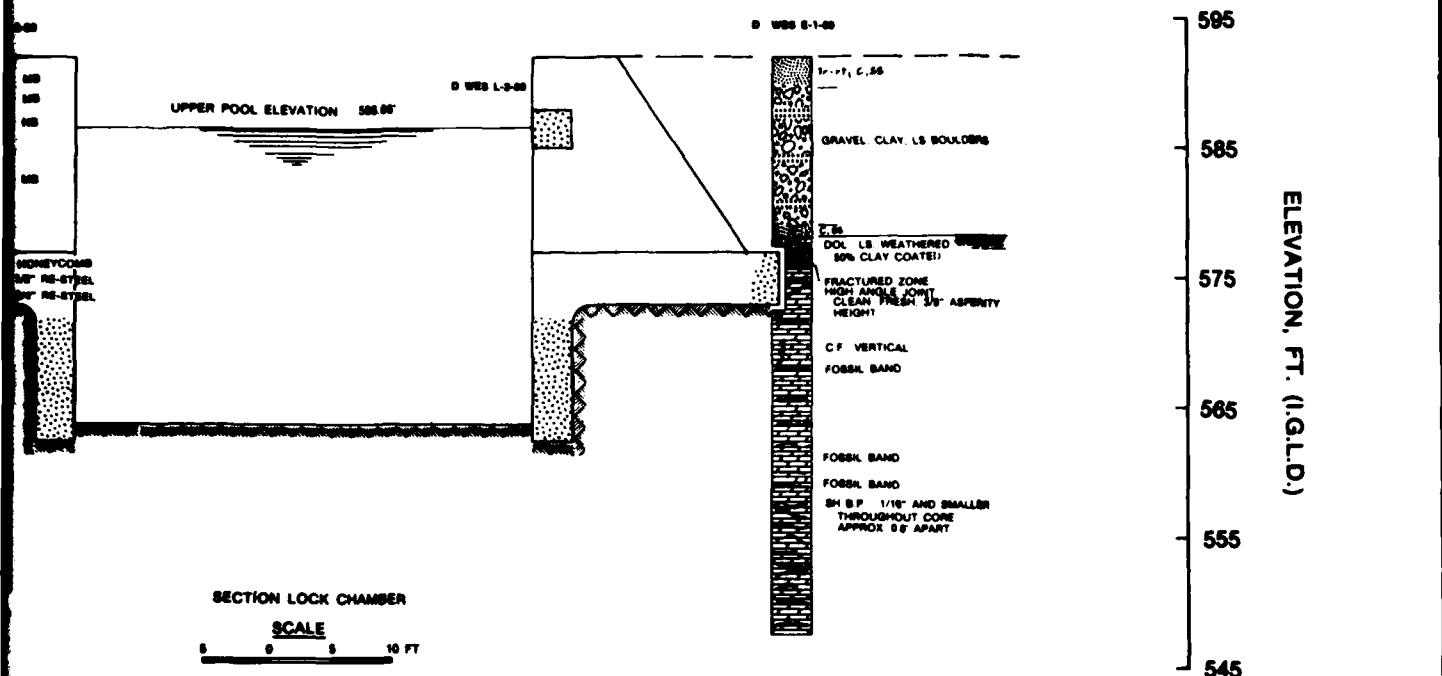
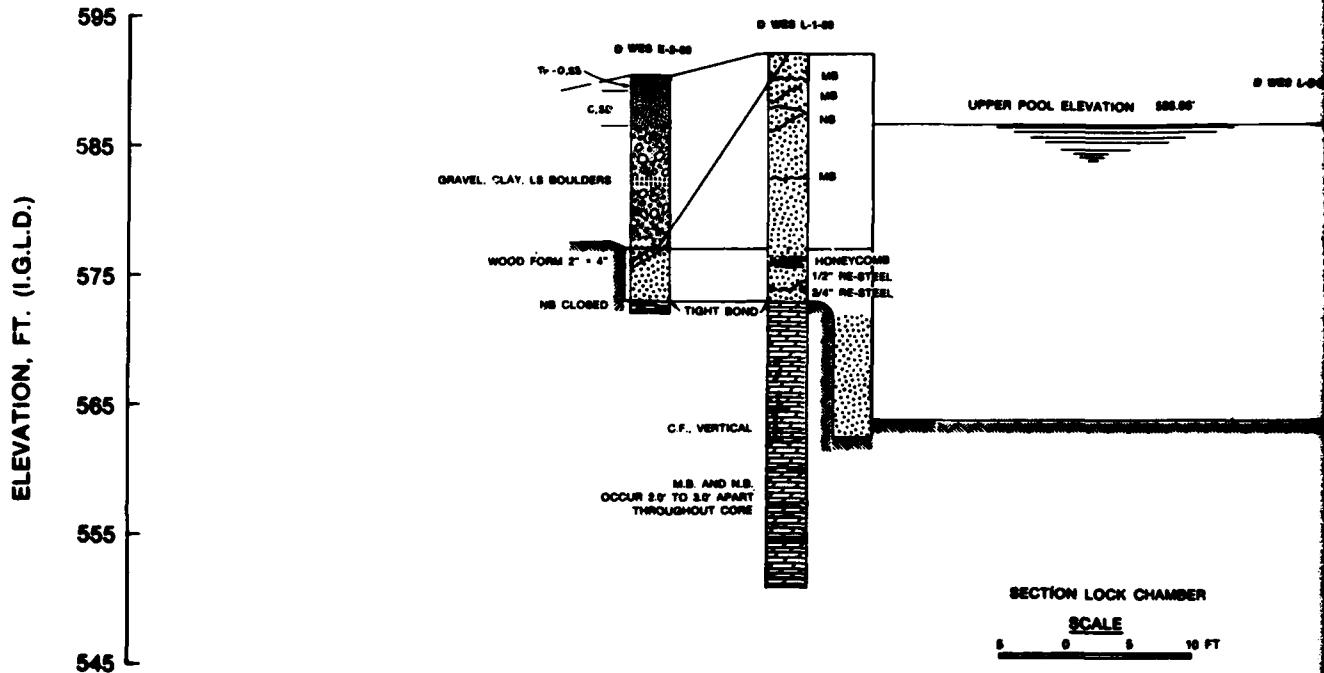
PLATE 5

40. Three geologic cross sections were drawn; sections A-A', B-B', and C-C' (see Plate 2 for cross section locations). Section A-A' (see Plate 5) was drawn perpendicular to the lock axis and includes borings E1, E2, and L1. Section B-B' (see Plates 6, 7, and 8) was drawn parallel to the dam axis, and section C-C' (see Plate 9) was drawn perpendicular to the dam at about its midlength. Section B-B' contains borings D1, D5, D6, D7, and D8, and section C-C' contains borings D1, D2, D3, and D4.

CONDITION SURVEY
AUGUST 1980
DEPERE LOCK AND DAM
GEOLOGIC CROSS SECTION
SECTION A-A'
